HAMPTON BAR DREDGING PROJECT
NEWPORT NEWS SHIPBUILDING AND DRY DOCK CO. BORROW SITE
MONITOR OF TURBIDITY AND SEDIMENTATION

March, 1974 - February, 1975

Hampton, Virginia

FINAL REPORT

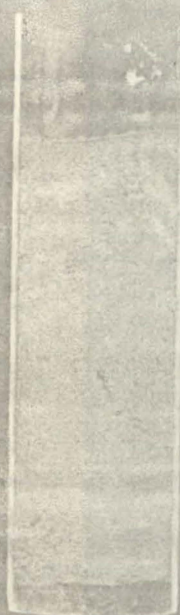
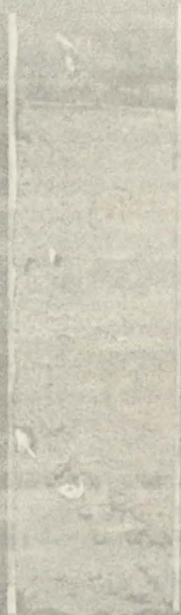
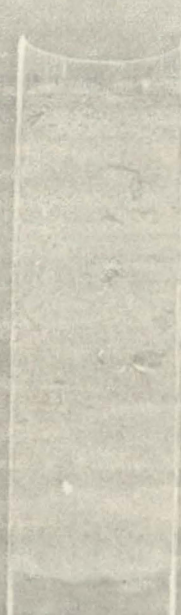
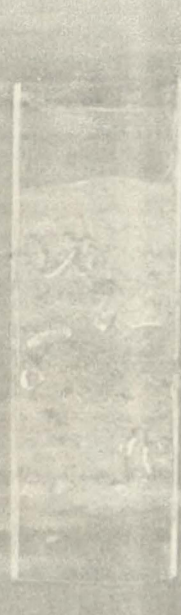
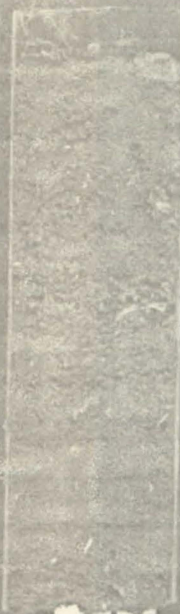
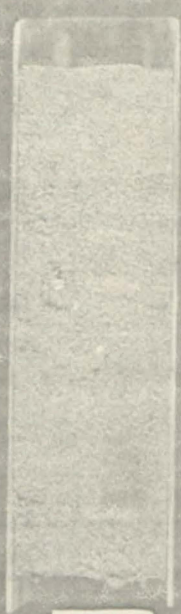
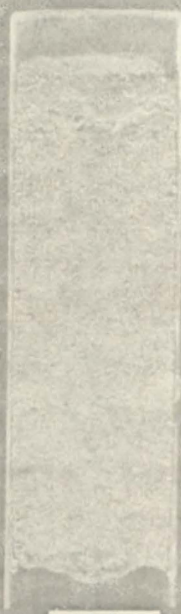
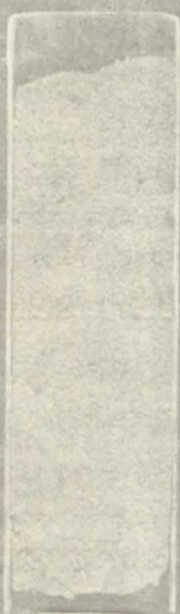
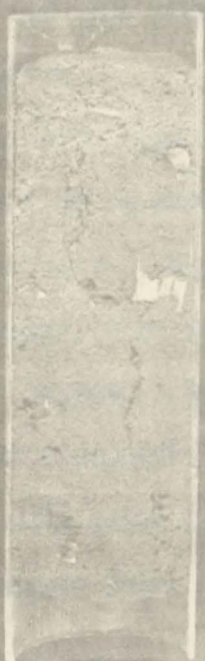
Figure 9. Photographs of sectioned cores, series a, b,
and c.

In most of the core photographs a granular texture can be observed extending right up to the sediment-water contact. This interface was ordinarily quite smooth (with the exception of cores 5b and 6b) and in several of the cores, a thin algal matting covered the very top of the sediment, indicating a lack of active sedimentation. Only core 1c, in fact, contained any visible stratification, the absence of which usually indicates a slow rate of deposition and/or active bioturbation (reworking by burrowing organisms).

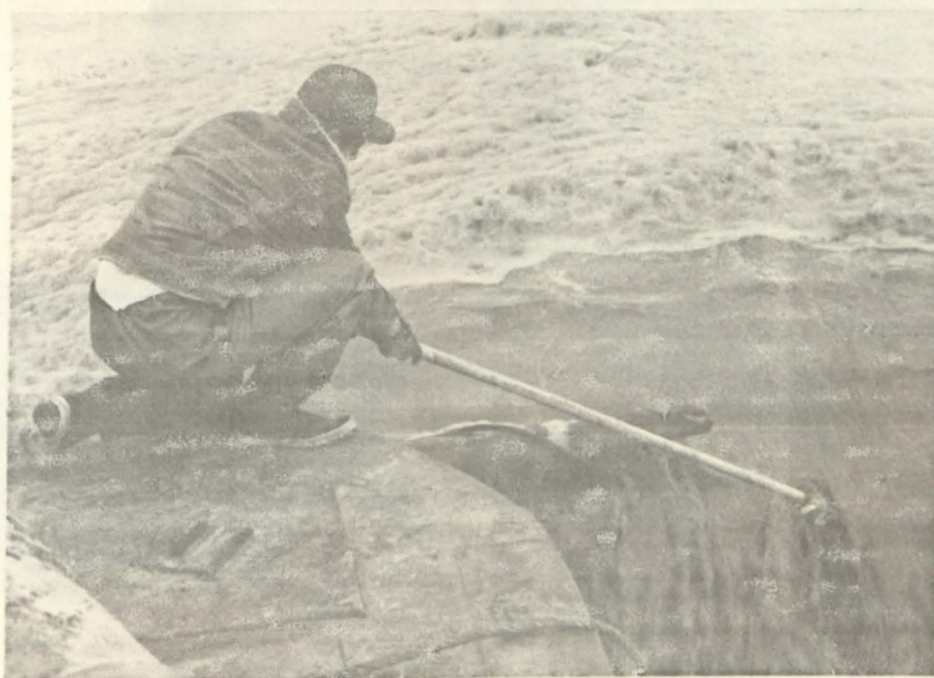
Scow Filling Operation: Figure 11a shows the spreader barge manifold unit dispensing fill into a scow (upper photo) and the collection of an overflow sample (lower photo). The three photographs in Figure 11b show the three routes by which excess water and sediment exited as overflow during a typical filling operation:

Figure 11. Hydraulic scow filling operation:

- a) spreader barge filling a scow; collection of overflow sample;
- b) photos showing routes of overflow.

3. Sheet flow over gunnels - The majority of the overflow simply spilled over the top of the gunnels (lower photo, Fig. 11b) once the scow had filled to capacity. A surcharge of water and sediment continued to be added, however, until the sand fill accumulating in the scow came within a foot or so of the surface. Sheet flow normally passed over the inboard gunnels alongside the spreader barge due to the scow's tendency to list in that direction while being filled.
